Performance of buildings with masonry infill walls during the 2011 Lorca earthquake

Lutz Hermanns · Alberto Fraile ·
Enrique Alarcón · Ramón Álvarez

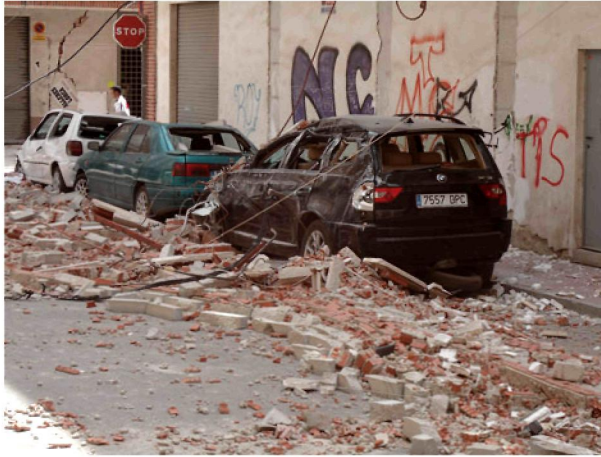
Fig. 1 Street covered with rubble of damaged buildings

As can be seen in Fig. 1 rubble was strewn across the streets from damaged buildings. Actually pieces of the facades that fell down during the earthquake injured a lot of persons. In some occasions façade infill panels located at upper floors and roof parapets collapsed and fell onto the ground. Two different failure mechanisms are thought to be responsible for their collapse.

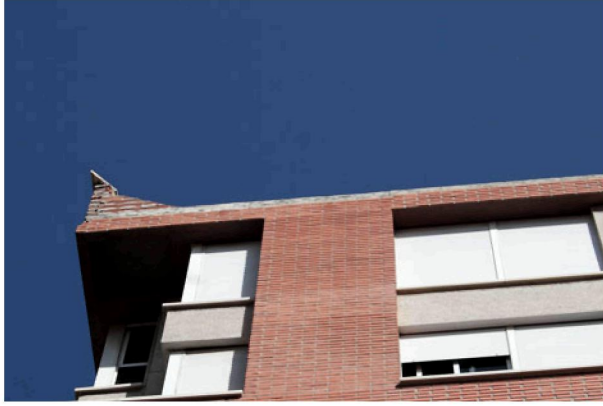
Fig. 2 Building with a partially collapsed parapet wall

The structure of this particular building did not suffer significant damage whereas the roof parapet almost completely collapsed. This type of incoherence in terms of the seismic behavior of different components of the same building is unacceptable.

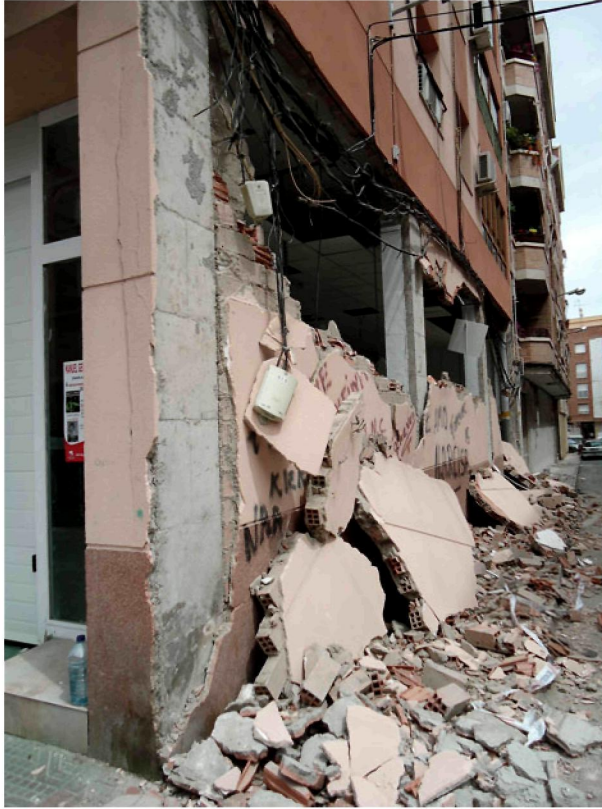
On lower floors the failure of masonry infill panels was caused by excessive in plane loads, displacements of the frame structure (see Fig. 3) and in some cases by pounding of adjacent buildings.

Fig. 3 Damaged masonry infill walls at ground floor

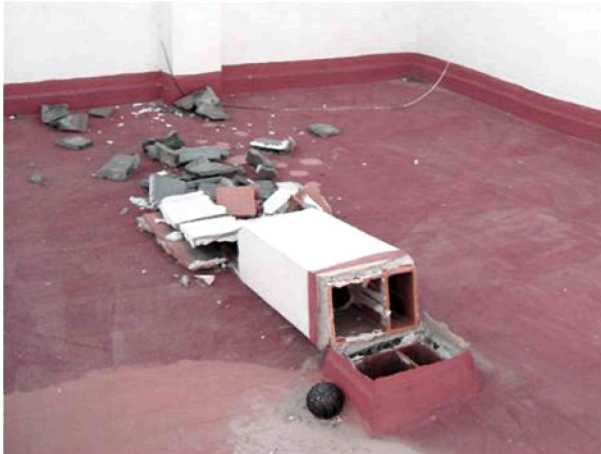
Fig. 6 Collapsed chimney on a flat roof

Not only parapet walls failed at this load level but also chimneys as can be seen in Fig. 6.

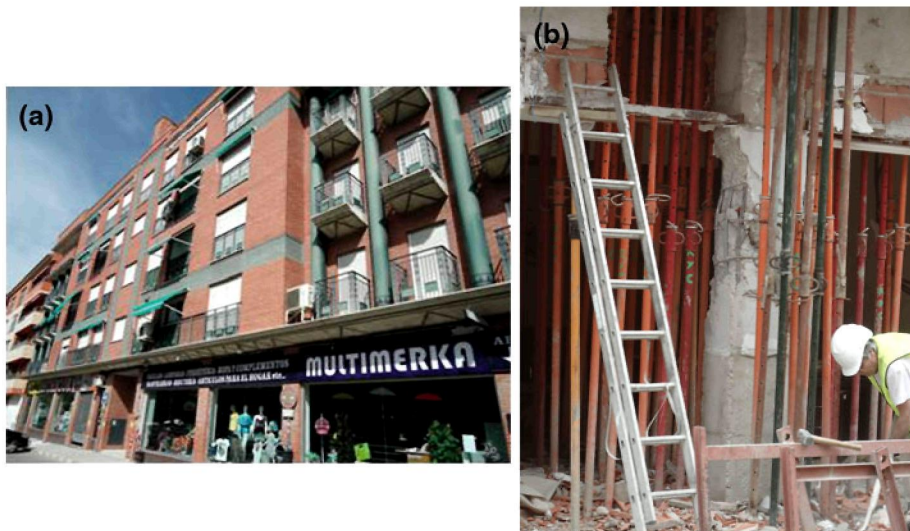
Fig. 7 a Buildings with a soft-storey, b severely damaged column

- Soft storey mechanisms due to infill panels with lower stiffness at the ground floor level and panels with higher stiffness at upper floors (see Fig. 7a).

- Masonry infilling effect on frame columns (see Fig. 7b). The horizontal displacements of the frame columns are restricted due to the presence of the infill wall. The reduced height of the column increases the forces the column experiences during a seismic event.

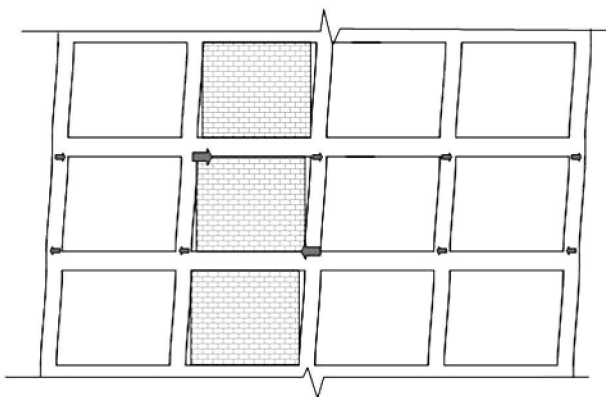
- Shear force concentration in combined systems consisting of RC columns and masonry infill walls (see Fig. 8). In order to estimate realistic shear forces during the design phase it is crucial to take the stiffness of the masonry infill wall into account however, quite often infills are not considered in the structural building model that is used for the seismic response analysis. It is quite common that only one infilled bay exists at ground level. In this case the infill is usually part of the elevator core walls.

Fig. 8 Shear force concentrations at beam–column junctions due to the presence of masonry infill

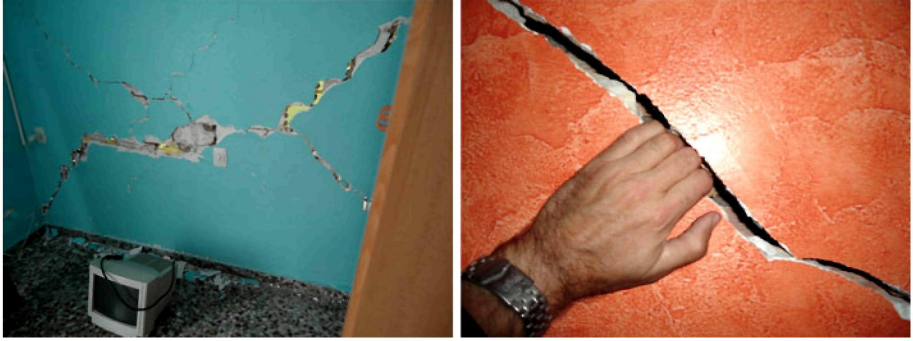
This simple example may explain the high number of damages observed in infill and partition walls (see Fig. 11).

Fig. 11 Examples of damaged partition walls during the Lorca earthquake

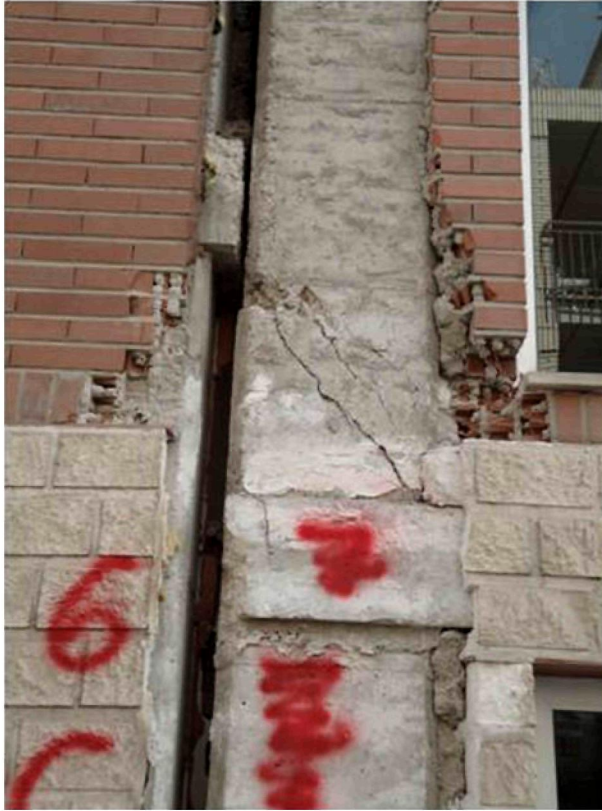
In Fig. 12a the mode shape corresponding to the model with intact infill panel at ground level is shown and in Fig. 12b the one corresponding to the model with the damaged infill panel at ground level. In Fig. 13 an example is presented where two buildings pounded resulting in damaged façade elements. Pounding occurred at the floor level of the first floor as a consequence of the reduced lateral stiffness of the ground floor of one of the buildings. The reduction in stiffness was due to a cracked infill panel at ground level.

Fig. 13 Example of buildings that suffered damage due to pounding effects

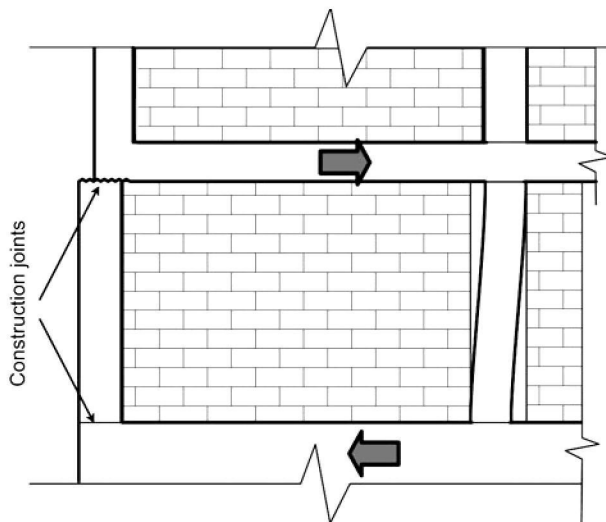
Fig. 16 Failure at the construction joint of beam–column connection

Construction joints in columns are usually located at the undersides of the slabs and beams as shown in Fig. 16.

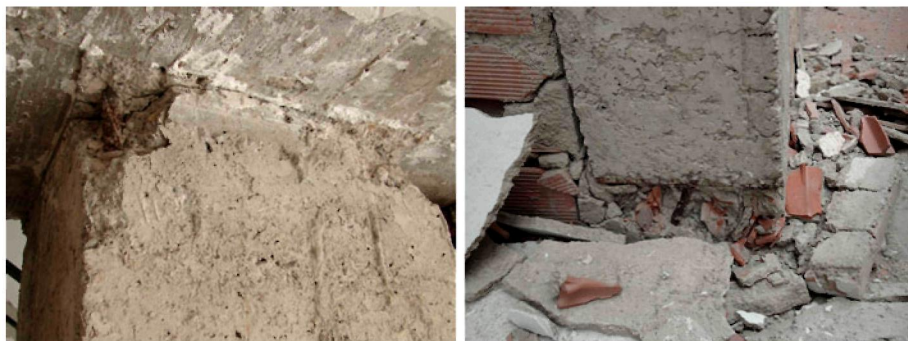
Failures of the contact surface were observed in several occasions (see Fig. 17).

This type of failure was observed particularly often in end bays of the exterior RC frames.

Fig. 17 Examples of failure at the construction joint of a beam–column connections

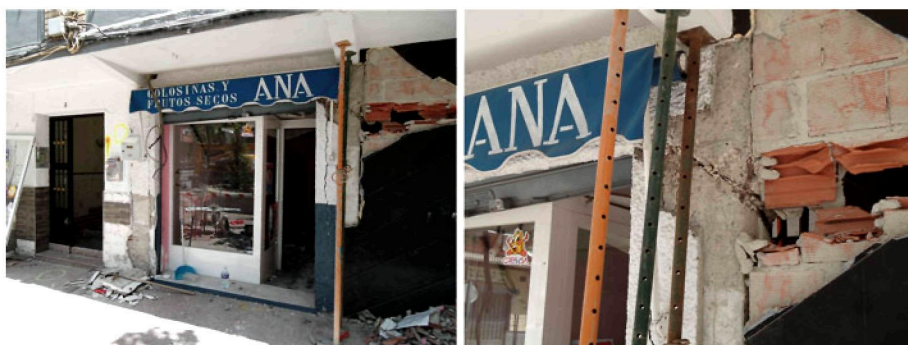
Fig. 19 Example of a shear-damaged column due to the failure of the adjacent infill panel

The formation of two struts may be favored by the existence of conduits, openings or other discontinuities in the infill panel (see Fig. 19).

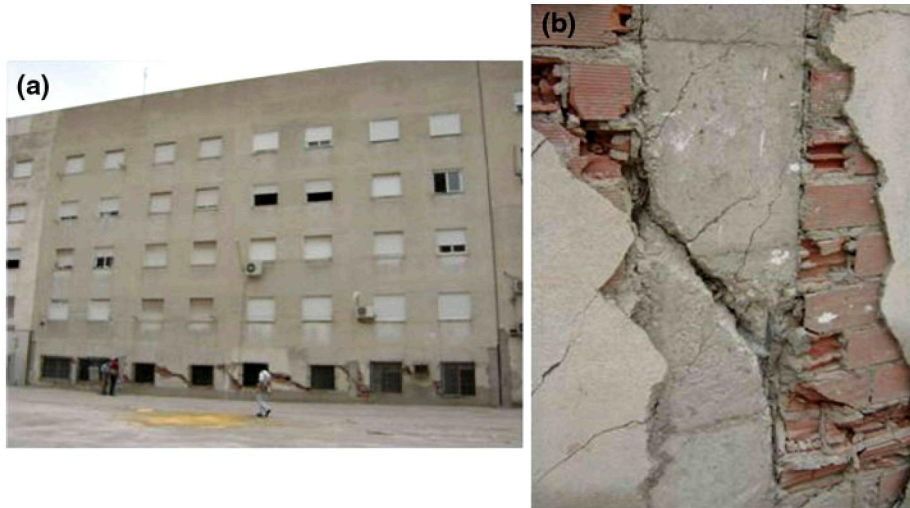
Fig. 20 Example of cracks crossing a column at mid-floor height. **a** Building, **b** detail

In general crack propagation in the infill panels indicates the position of the traction diagonal that connects two beam–column connections however, in some cases the cracks in the infill panels developed laterally displaced crossing the column at mid height like in Fig. 20b.
